# HUNTERS POINT SHIPYARD PARCEL E EMERGENCY REMOVAL ACTION LANDFILL GAS CONTROL SYSTEM

### WEDNESDAY 2, OCTOBER 2002 DAILY ENGINEER'S REPORT

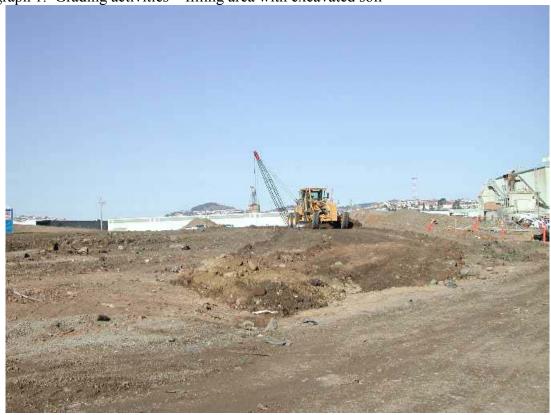
Photograph 1. Grading activities – filling area with excavated soil

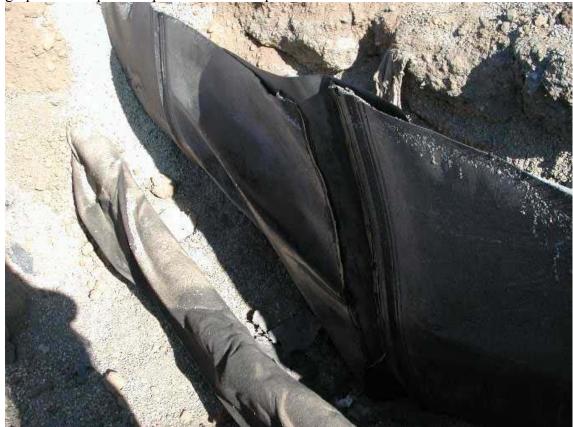
Photograph 2. Completed repair to Gundwall panel at STA 7+52

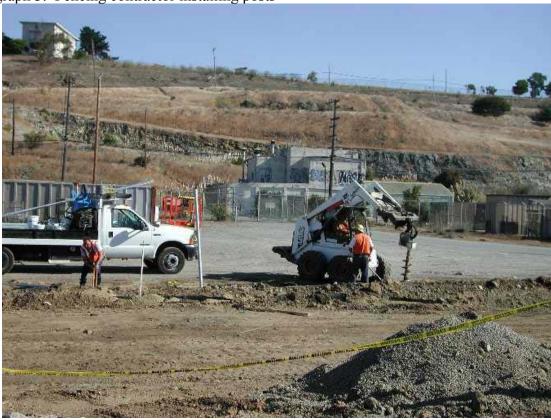
Photograph 3. Fencing contractor installing posts

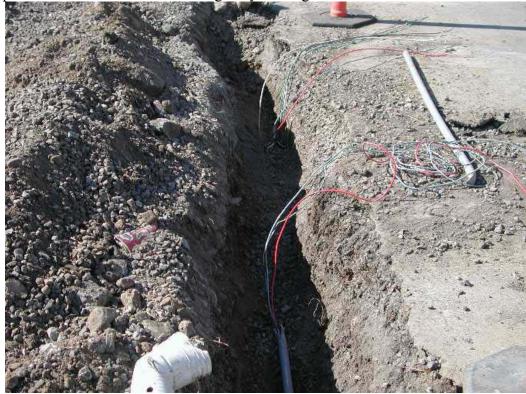
- Began installation of UCSF replacement fencing. Activities were halted when the
  contractor drilled in to the electrical line that powers the UCSF access gate and cameras.
  ITSI called out an electrician. No repairs were possible until UCSF personnel were
  contacted to provide detailed information regarding the lines. ITSI will be continually
  coordinating with UCSF personnel to get line properly repaired.

Photograph 4. UCSF Electrical line damaged by fencing contractor

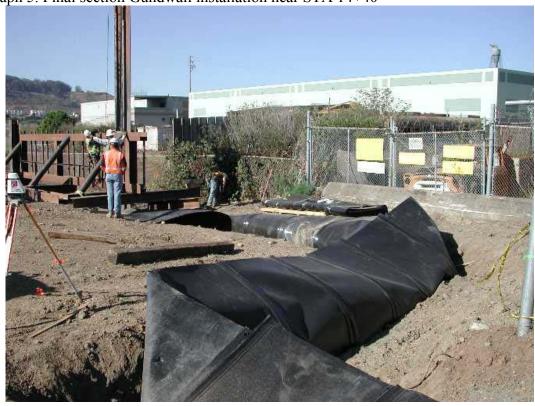
Photograph 5. Final section Gundwall installation near STA 14+40

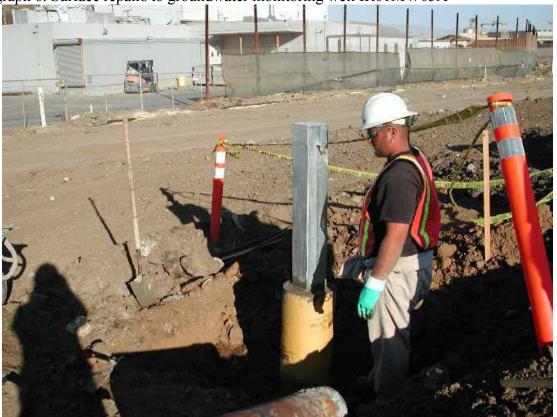
- Completed installation of replacement groundwater monitoring well IR01P03A and complete surface repairs to IR0103AA and IR01MW05A.
- Began grading activities by filling area with the stockpiled soil from excavation activities.

Photograph 6. Surface repairs to groundwater monitoring well IR01MW05A

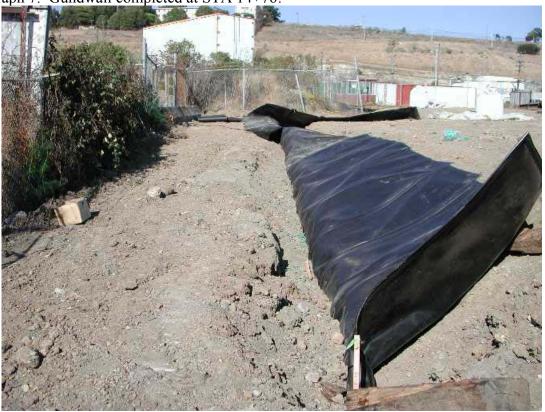
Photograph 7. Gundwall completed at STA 14+76!
